Project 68604.00 Rev 03
19 July 2017
SJ:BS

Report on Bulk Earthworks Level 1 Supervision and Testing
Emerald Hills Estate Stages 13B, 14A, 14B and 15
Heritage Drive, Brassall

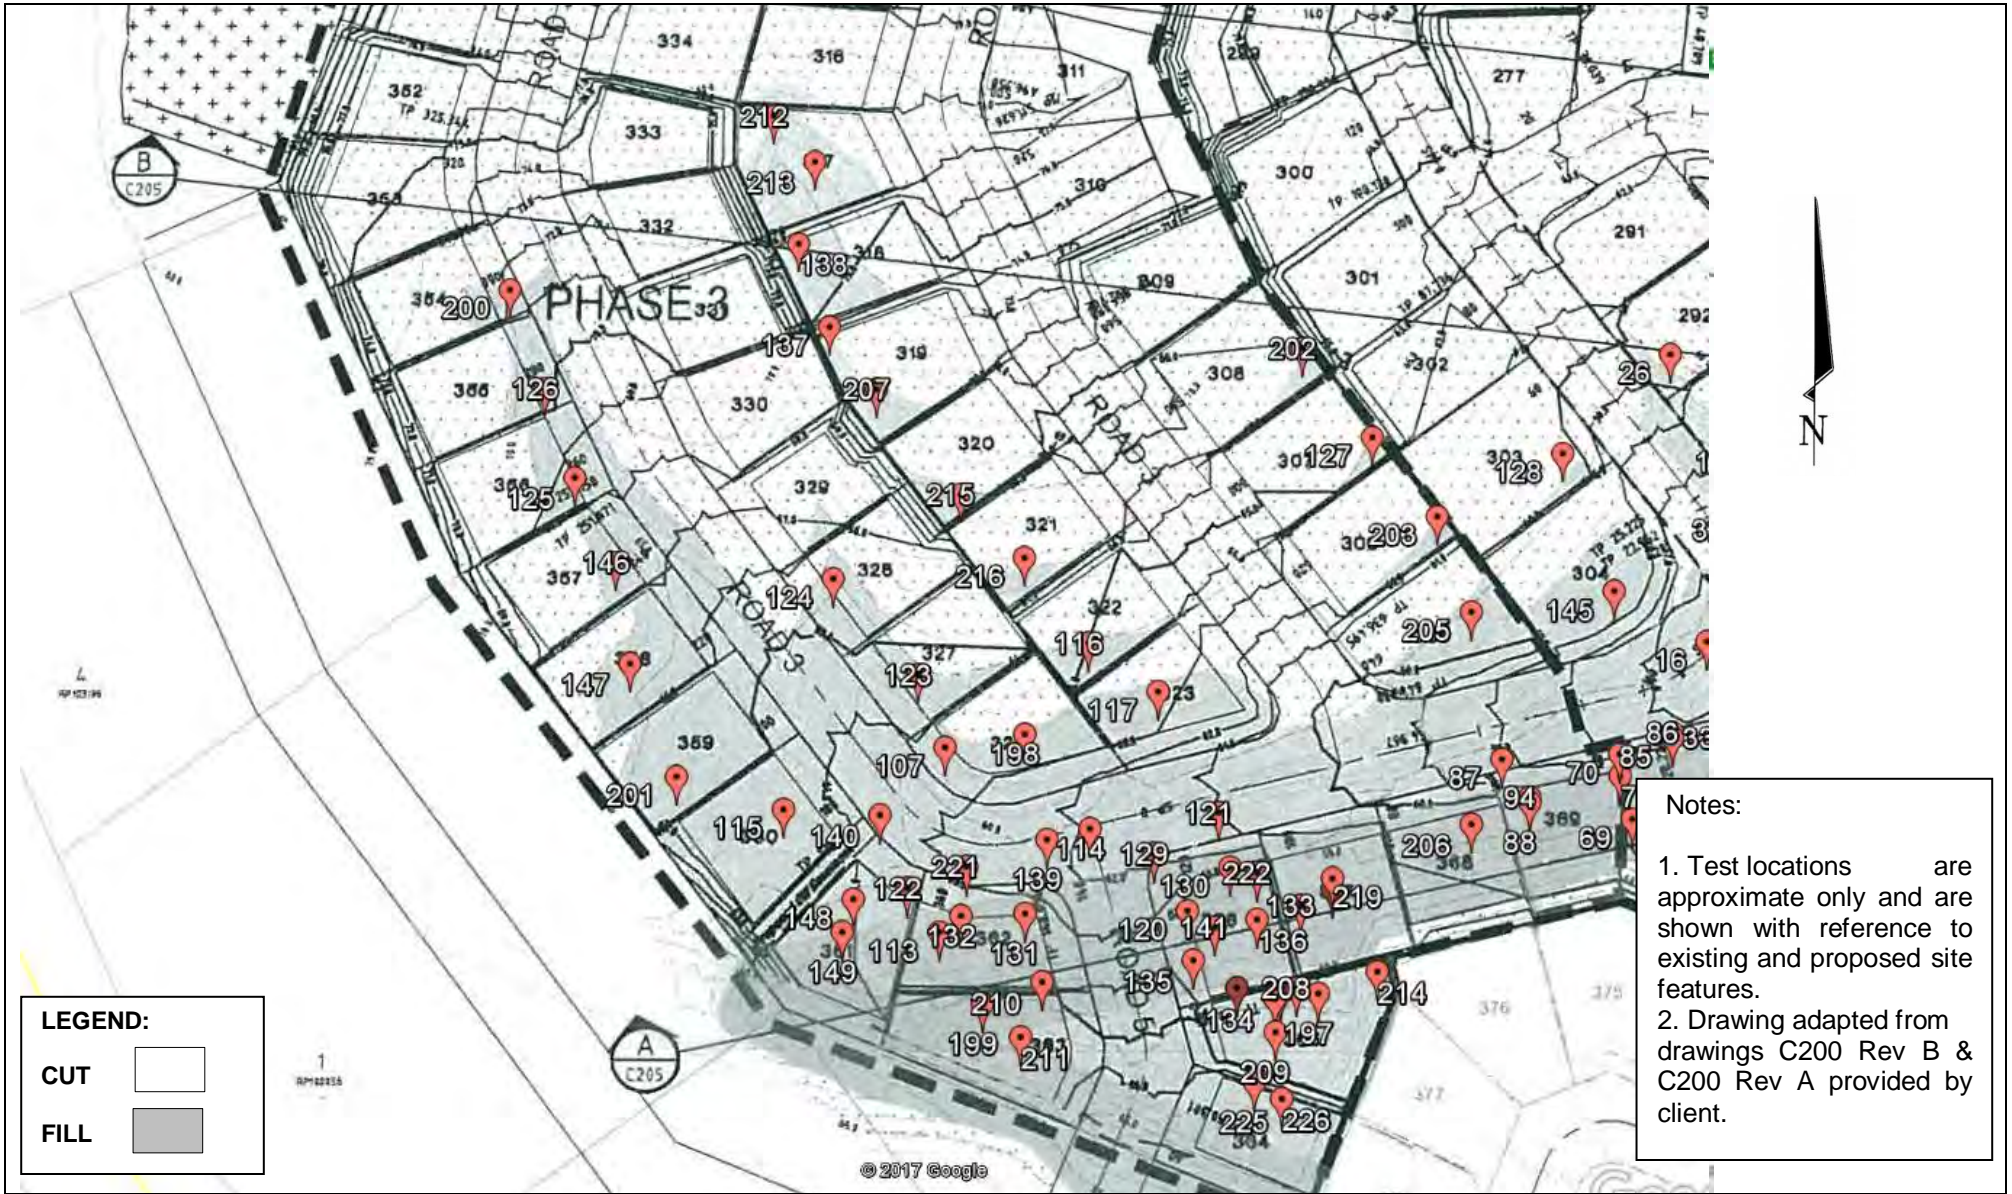
<p>Douglas Partners Geotechnics Environment Groundwater</p>	CLIENT: Shadforths Civil Contractors	<p>Bulk Filling Test Locations</p> <p>Phase 3</p> <p>Heritage Drive, Brassall</p>	PROJECT No: 68604
	OFFICE: Brisbane		DRAWING No: P3.17.A
	DATE: 19.07.2017		REVISION: -

1. Test locations are approximate only and are shown with reference to existing and proposed site features.
2. Drawing adapted from drawings C200 Rev B & C200 Rev A provided by client.

The extent of bulk filling placed for Stage 13B, 14A, 14B and 15 of the Emerald Hills Estate, is indicated on Drawings P2P3.17,P2.17.A,P2.17B and P3.17A attached. Multiple drawings are provided for clarity.
